# EAGLE GOLD

## TRANSMISSION CONNECTION

## PROJECT OVERVIEW

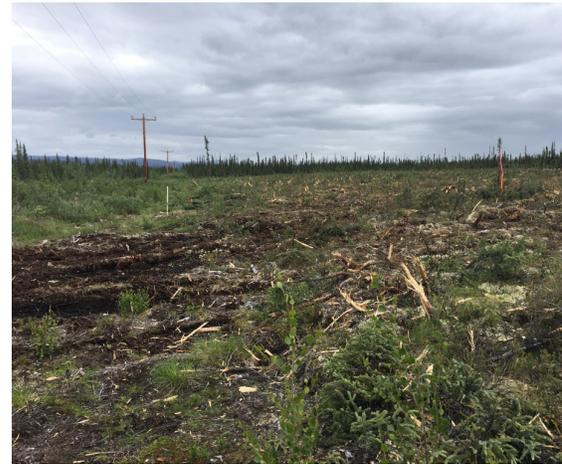
*Original location (Location 1)*

ATCO completed the preliminary civil design for the original substation location in 2016. We based the design on a 2015 geotechnical report completed primarily for site selection. Approximately 40 km from Mayo, the original substation location (Location 1) was the preferred of three sites evaluated, given the relatively dry and firm ground with no permafrost.

detailed design in 2017, we requested a detailed geotechnical investigation of Location 1; Tetra Tech drilled three new boreholes, one in the cleared right of way and two at the substation location. The substation boreholes revealed permafrost to a depth of 4 m, with approximately 2 m of ice-rich content (30 – 40%).

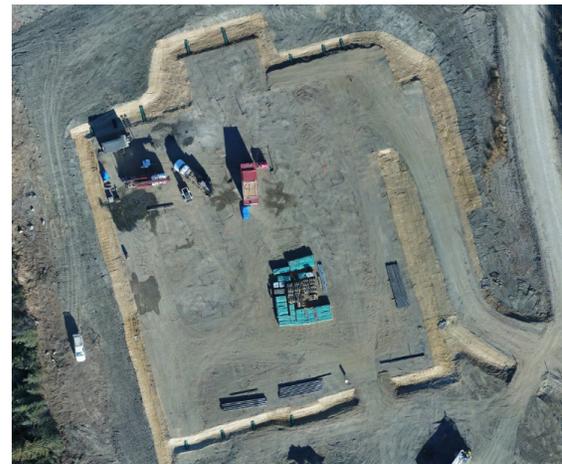
*New site after earthworks completed*

After analyzing the execution challenges and potential cost and schedule impacts, ATCO proposed a new site at an old open pit 200 m west of the original site.
